# **M/V NORTHERN VIGOR**

**REPORT OF** April 21, 2014

**SUBJECT:** Pilot Injury on Boarding  
About 6.5 miles NW of the CR Buoy

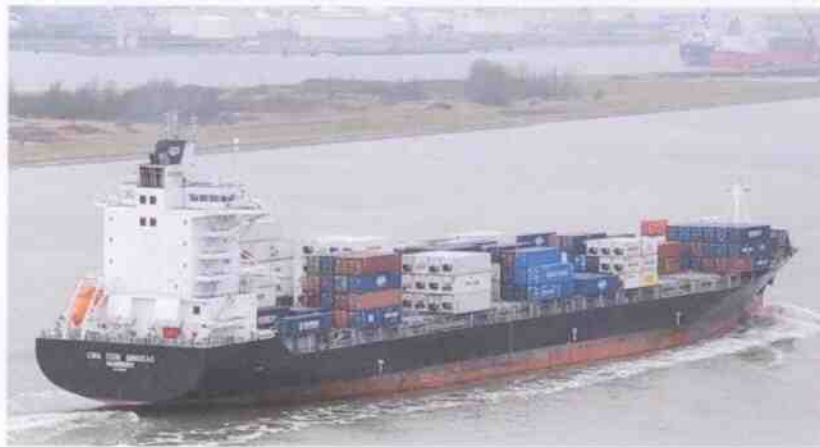
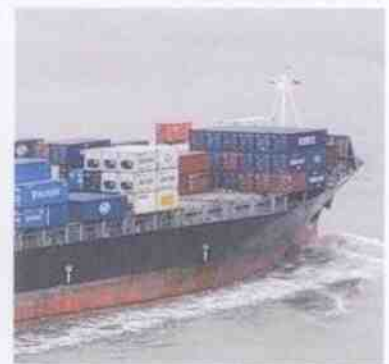
This picture shows what the clear hatch at # 2 would have looked like. This is not the actual stow at the time of the incident.

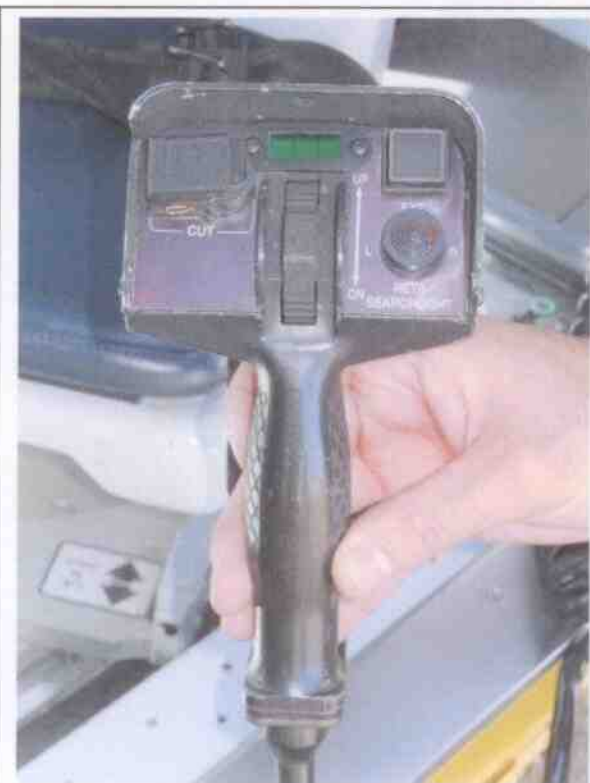
Winch controller. The cutter door with the button under is on left.

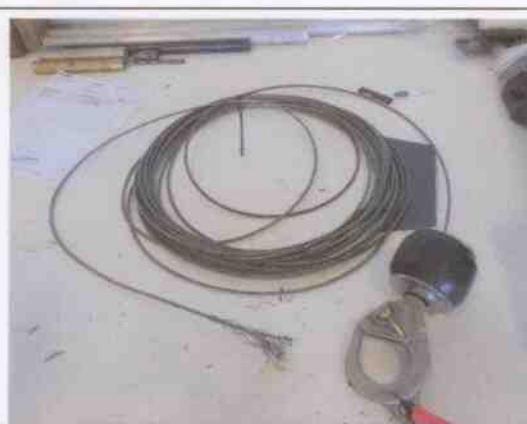
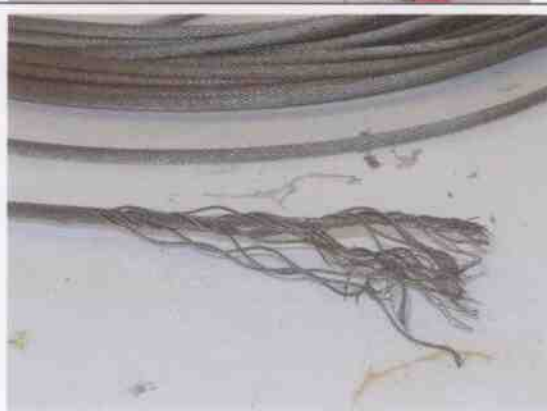
The helicopter was moved into location over the open hatch and the hoist begun. The helicopter was in a hover 20-25' above the deck, canted a little to the right of the ship's heading so as to be headed into the wind. The helicopter pilot was using the containers forward of the open space as his reference point while the winchman conned him into position over the desired spot, after which the helicopter pilot held her in a stationary hover. The bar pilot was lowered in a normal hoist with no excessive swinging down to the hatch cover. He was on deck, as the wire went slack, and in the instant it took to release the hook the helicopter pilot lost reference and started to fall back relative to the ship. The winch operator felt the wire go slack and then had it take tension again, but could no longer see the pilot. He paid out wire as fast as possible. When he could not pay out fast enough to put slack in the wire he made the decision to fire the cutter, releasing about 80' of wire to fall to the ship (see pictures).

The wire from the hook to where it was cut and a close up of the cut end.
